## Case Studies in Atomic Force Probe Analysis

Randal Mulder, Sam Subramanian, Tony Chrastecky

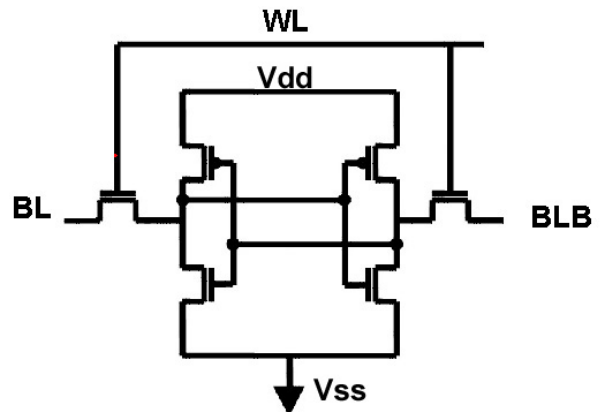
**Figure 1:** Schematic of a 6T SRAM bit cell shows that five nodes BL, BLB, WL, VDD, and VSS have to be biased for the electrical characterization of the bit cell.

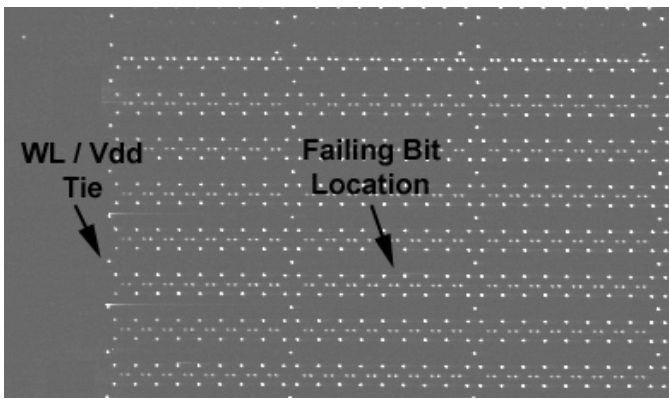
**Figure 2:** Ion beam image of a 0.25 CMOS SRAM array. The Metal 3 bit lines have been polished off exposing the Via 2 plugs. The failing bit cell location and the location of the WL/VDD FIB connection at the edge of the array are shown.

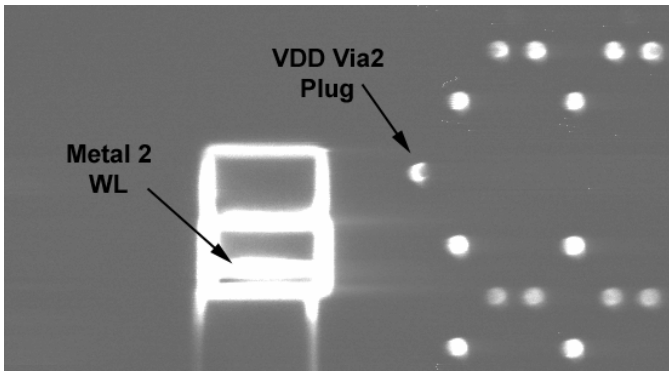
**Figure 3:** Close-up ion beam image of at the edge of the array. A FIB hole was cut through the oxide to expose the Metal 2 word line.

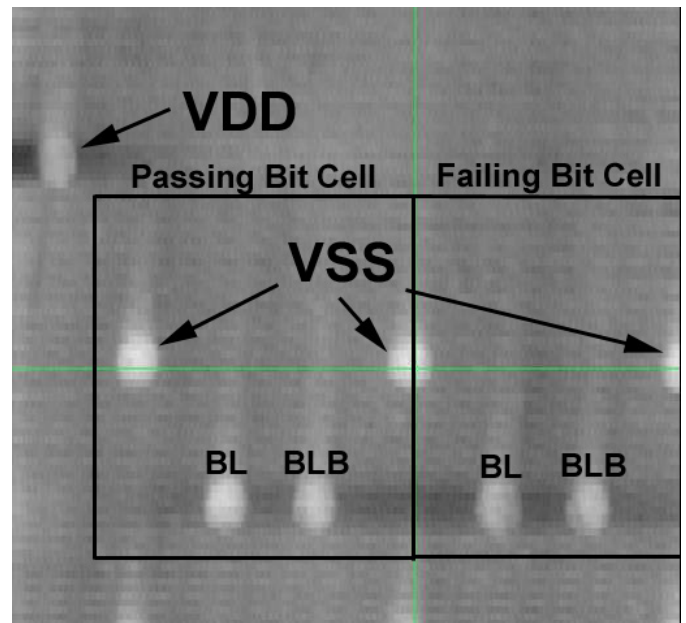
**Figure 5:** Topographical AFP image of the top of Via2 plugs after the removal of Metal 3 for a failing 0.25um SRAM bit cell. A FIB was used to connect the word line (WL) to the VDD metallization. Complete bit cell characterization was performed with the AFP at these Via2 plugs.

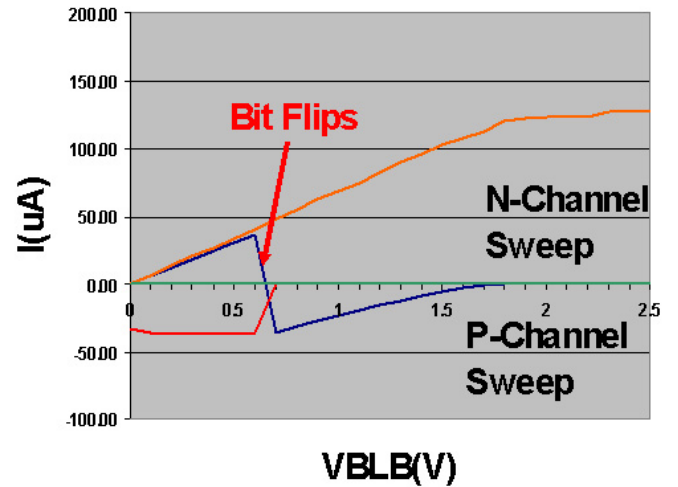
**Figure 6:** AFP electrical characterization results for the failing SRAM bit cell. The bit cell flips data states when the bit line bar (BLB) p-channel load transistor is swept indicating a series resistance problem between the bit line (BL) storage node and the bit line connection to the bit cell based on Spice simulation models.

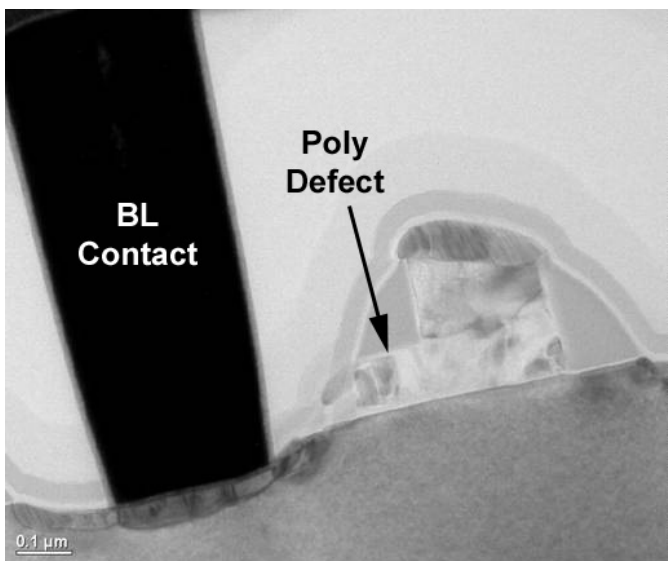
**Figure 7:** TEM cross section image of the failing node shows a poly defect in the gate of the pass gate transistor. The length of the transistor channel is increased causing greater channel resistance just as the electrical analysis and Spice modeling had predicted.

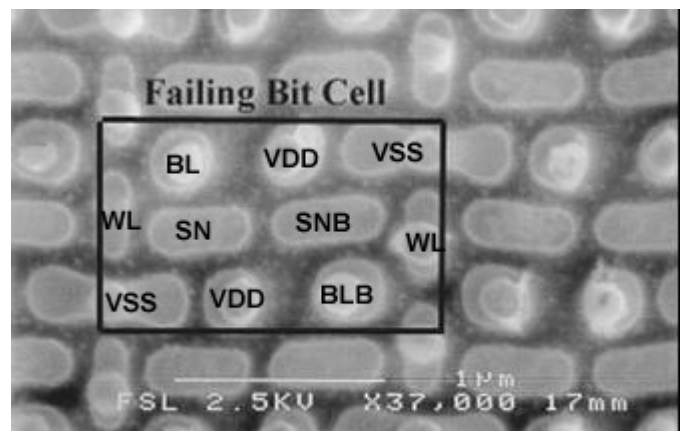
**Figure 8:** SEM image of a failing 90nm ultra high density SRAM bit cell failure. The sample has been deprocessed to Metal 1 exposing Via 1 and Metal 1. SEM inspection did not reveal a short or defect at the top of Metal 1. (SN = storage node and SNB = storage node bar)

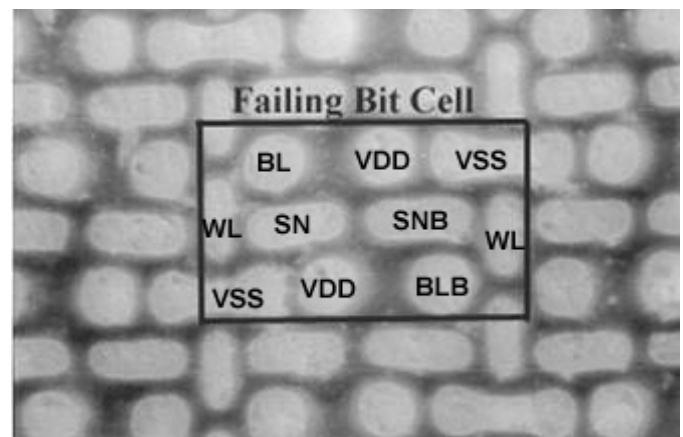
**Figure 9:** SEM of Metal 1 after polishing to remove Via 1 and to planarize Metal 1 and the ILD0 for AFP analysis. The AFP is now able to scan and probe the Metal 1 to determine if the contact to Metal 1 interface is resistive or if there are metal shorts at the bottom of Metal 1.

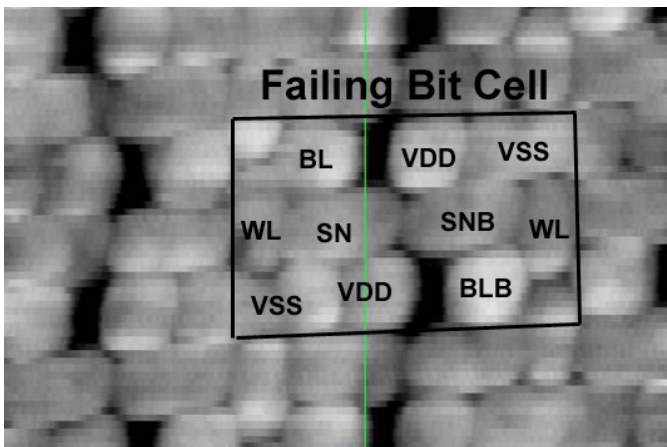
**Figure 10:** Topographical AFP image of Metal 1. AFP probing of the adjacent Metal 1 lines within the failing bit cell did not indicate a short at the bottom of the metallization.

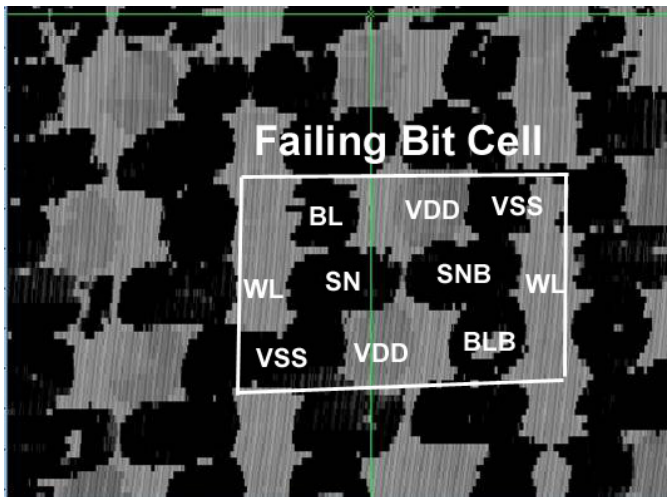
**Figure 11:** Current Contrast AFP image of the Metal 1 layer. The results showed that the Metal 1 storage node(SN) lines do not have a resistive interface to the underlying contacts. The probing and current contrast imaging has eliminated a defect in the Metal 1 layer as the possible cause the bit cell failure.

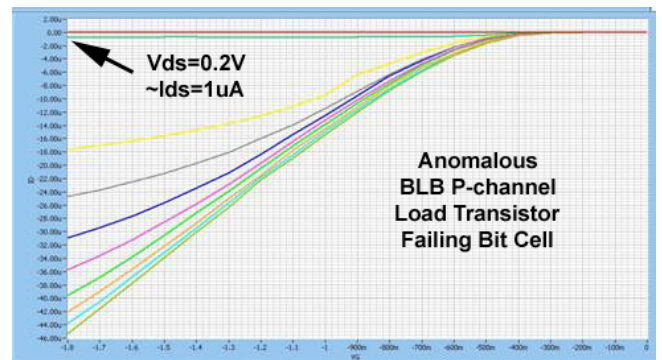
**Figure 12:** Traditional AFP probing on the contacts found a p-channel load transistor in the failing bit had low conductivity at low Vds. Ids measured 1uA at Vds=0.2V.

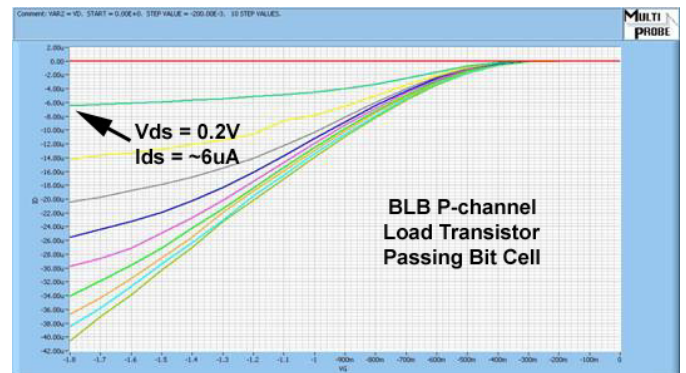
**Figure 13:** Probing with the AFP on the contacts of a passing bit cell found that Ids measured 6uA at Vds=0.2V for the p-channel load transistors.

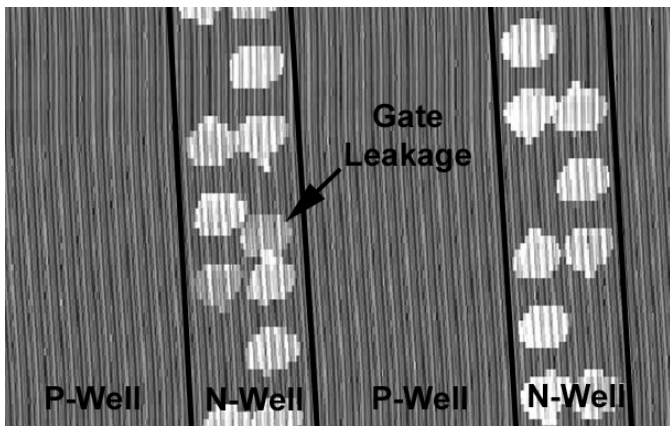
**Figure 14:** AFP current contrast imaging of a bulk semiconductor device. In this image, the n-well has been biased to ground with one of the probe tips while another probe tip is biased with a positive voltage and scanned over the failing bit. The biasing causes current conduction through the source/drains of the p-channel transistors to the well. A gate contact is also visible due to a damaged gate oxide that allows for current conduction to the well.

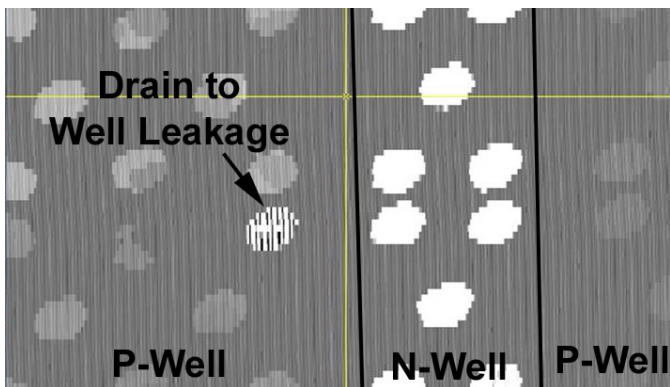
**Figure 15:** AFP current contrast imaging of a bulk semiconductor device using the light on the microscope at high magnification to bias both the n and p doped silicon. The probe tips are biased to ground as they scan over the area of interest resulting in the conduction of current.

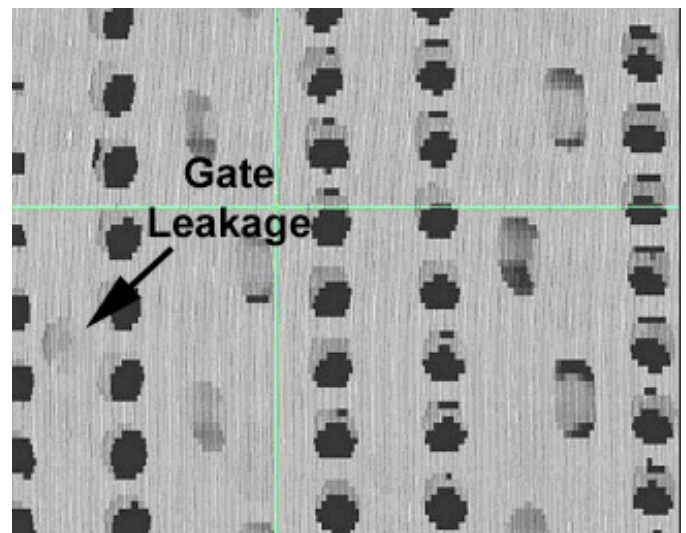
**Figure 16:** AFP current contrast imaging of a SOI SRAM array using the light on the microscope at high magnification to bias both the n and p substrate under the gates. For this device, a gate contact is visible indicating leakage through the gate.

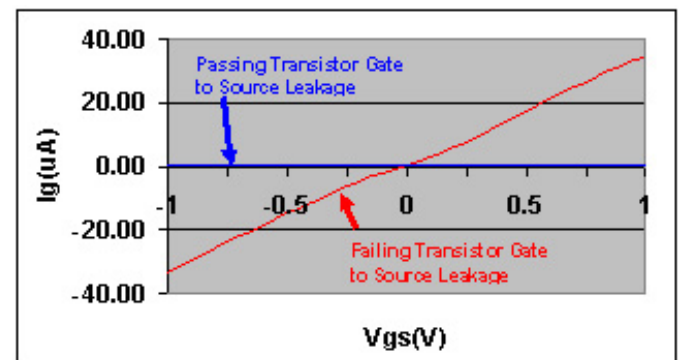
**Figure 17:** AFP probe results for the gate contact shown in Figure 16 shows gate leakage to the source of the transistor.

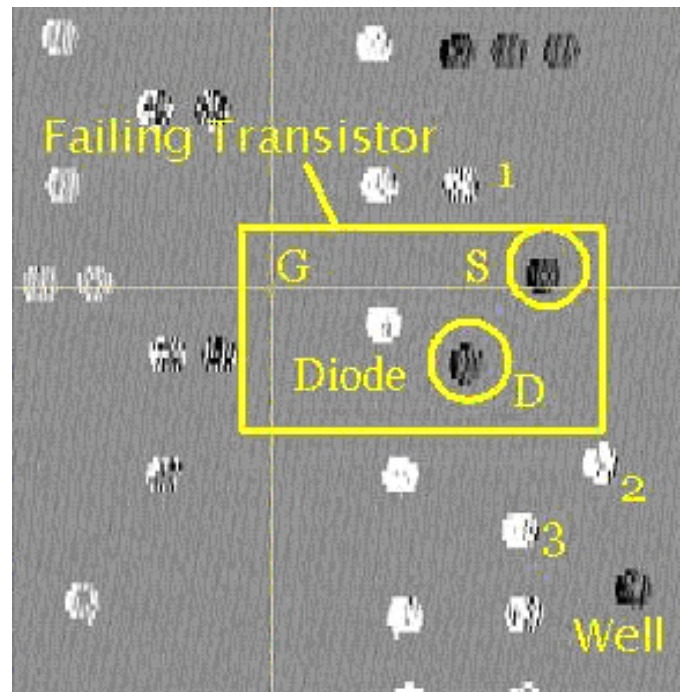
**Figure 19:** Current contrast AFP image of the transistor shows that the source/drain contacts for the suspect transistor had a different contrast than the surrounding source/drain contacts indicating that they were leaking to the p-well.

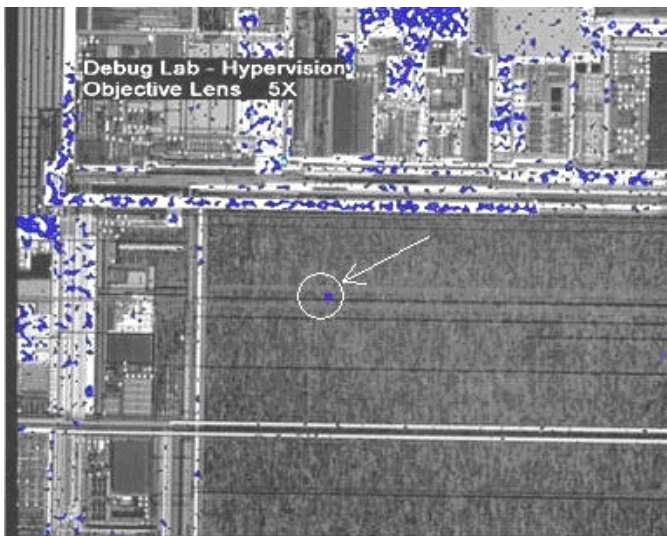
**Figure 18:** Light emission analysis identified an emission spot in the logic of a device that failed standby IDD. Light emission results provide by the Freescale Tempe Product Analysis Lab.

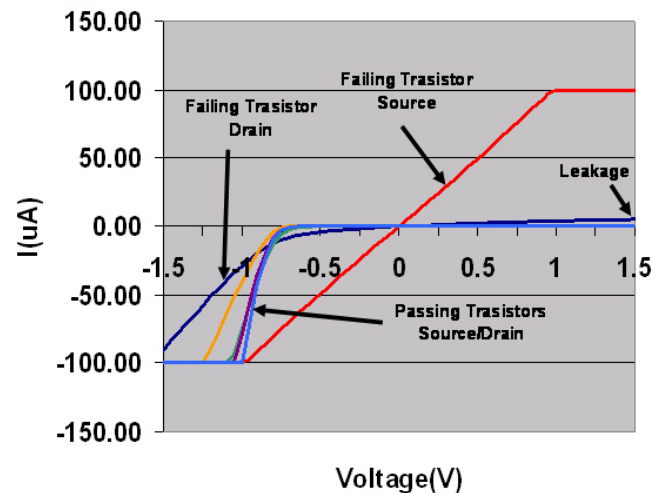
**Figure 20:** Two probe AFP measurements of the suspect transistor showed that the source and drain were leaking to the p-well.

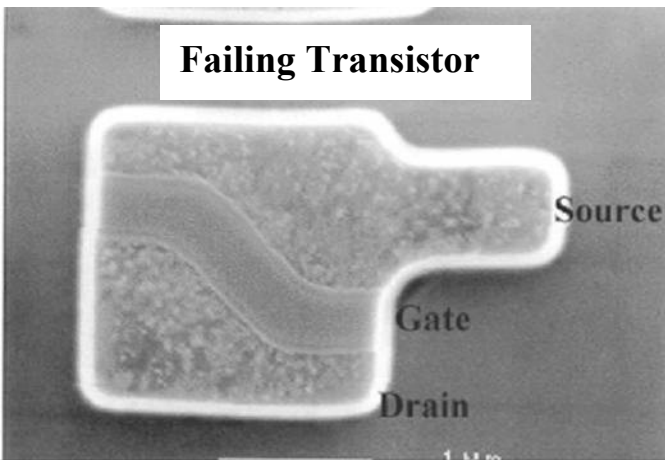
**Figure 21:** The sample was deprocessed down to substrate and inspected with the SEM. No contact spike or silicide problem was found.

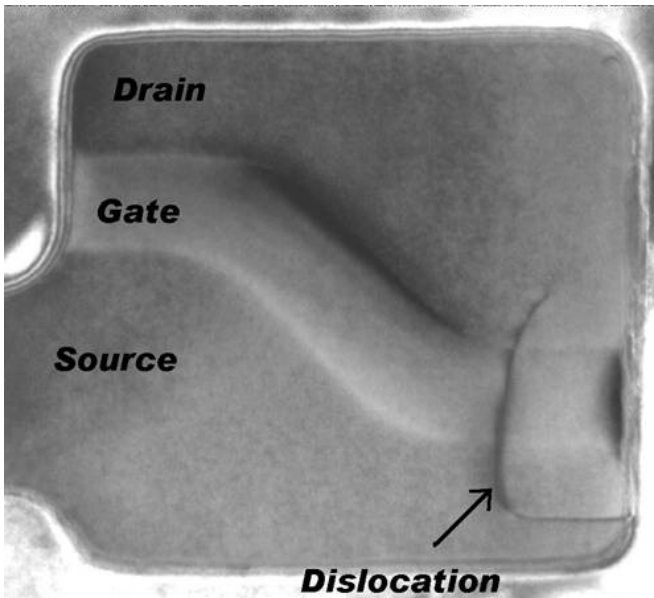
**Figure 22:** Planar TEM image of the failing transistor shows a dislocation in the substrate that starts at the trench on the Source side and extends across the Gate to the Drain. This was the source of the light emission and the standby IDD failure. The combination of light emission, AFP, and TEM analysis resulted in the determination of the failure mechanism in a relatively short amount of time.

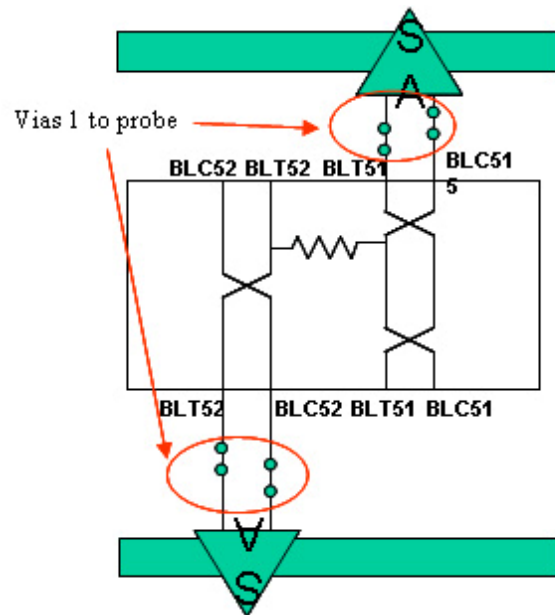
**Figure 23:** Schematic of the DRAM columns showing the desired location to probe.

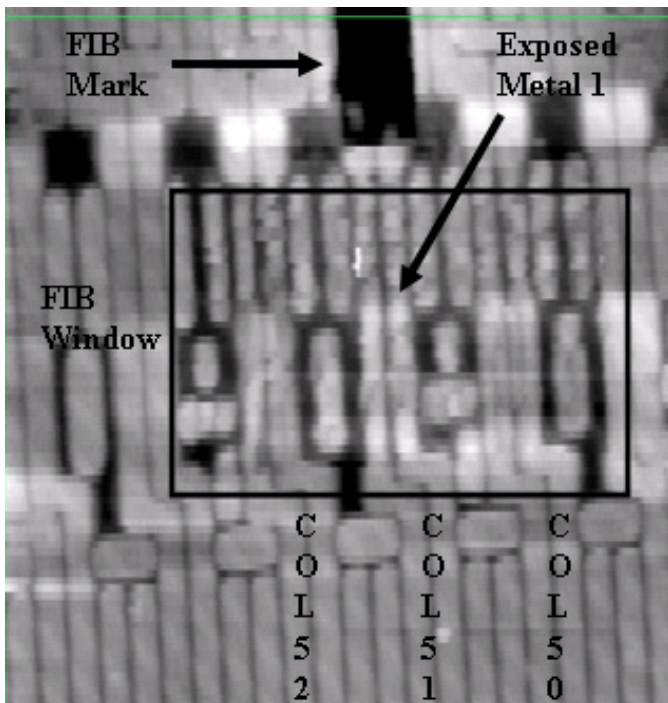
**Figure 24:** AFP topographical image showing the failing columns 51 and 52 after the FIB was used to expose the Metal 1 lines.

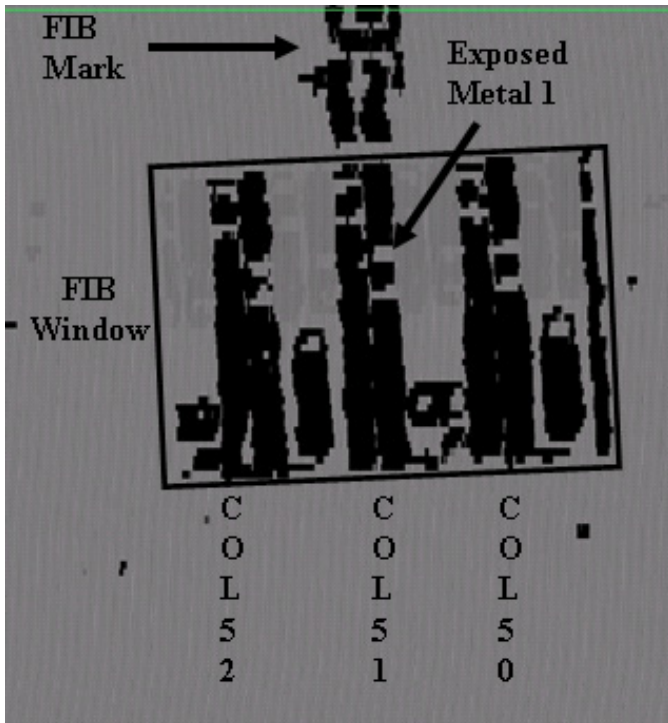
**Figure 25:** AFP current contrast image showing the failing columns 51 and 52 Metal 1 lines are exposed and available for probing.

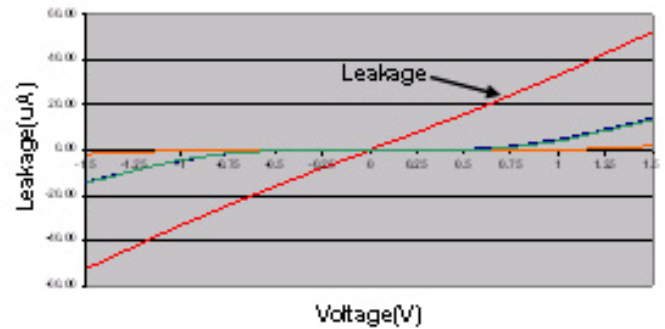
**Figure 26:** AFP probe results shows leakage between Metal 1 lines of column 51 and 52.

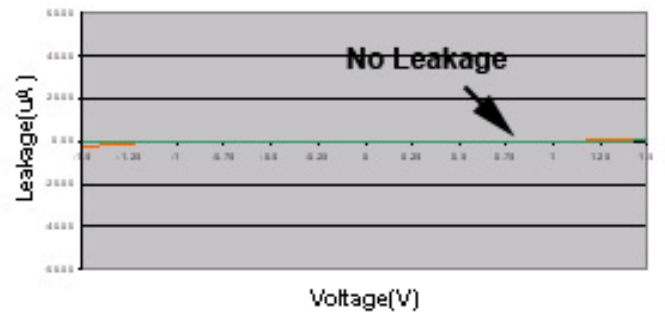
**Figure 27:** AFP probe results showing no leakage between Metal 1 lines of column 50 and 51 compared to columns 52 and 52 in Figure 26.

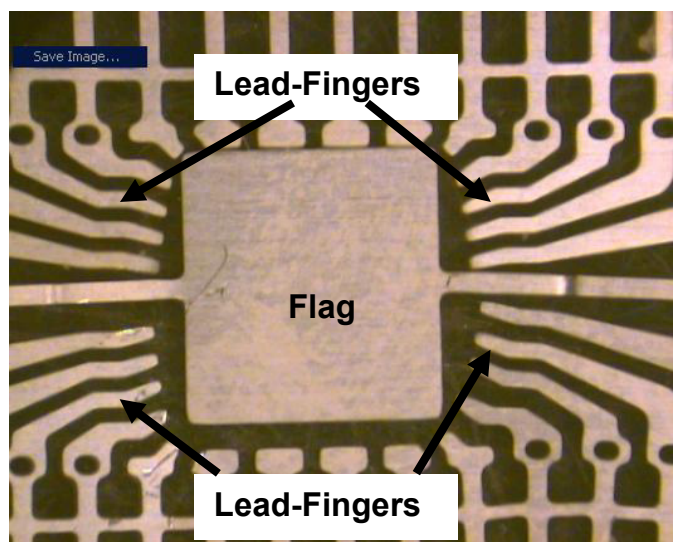
**Figure 28:** Optical photo of a package lead-frame with no roughing agent sprayed onto the surface.

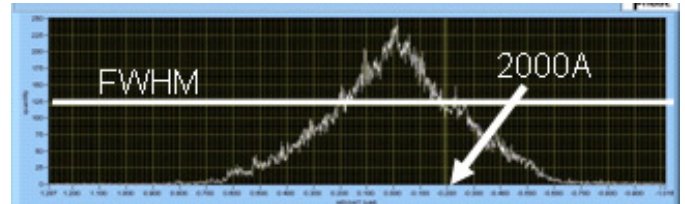
**Figure 35:** The distribution of the AFP measurements at the FWHM point gives a measurement of  $\pm 2000\text{A}$  for the lead-frame with the 2000A roughing agent.

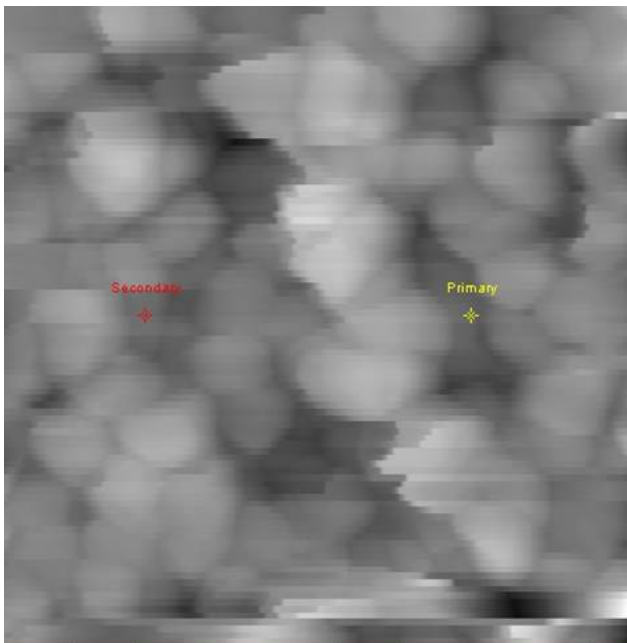
**Figure 31:** Topographical AFP image of the lead-frame with 2000A roughing agent. The particulates can be clearly seen.
