SCANNING ELECTRON MICROSCOPE INDUCED ELECTRICAL BREAKDOWN OF TUNGSTEN WINDOWS IN INTEGRATED CIRCUIT PROCESSING

David M. Shuttleworth*
Agere Systems, Orlando, Florida

Abstract

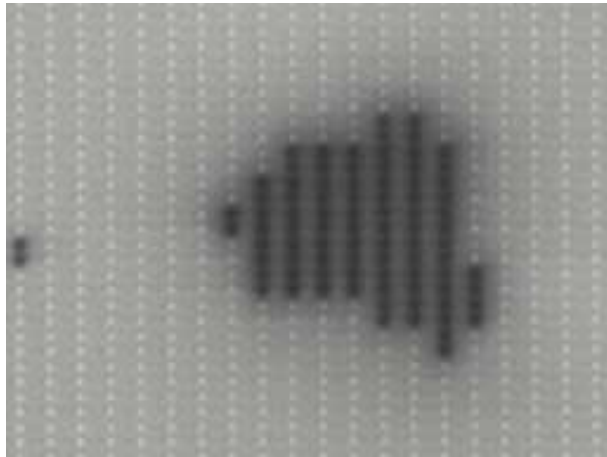
Figure 1: SEM Inspection of Processing Defect At Window-1 Level, After Tungsten CMP

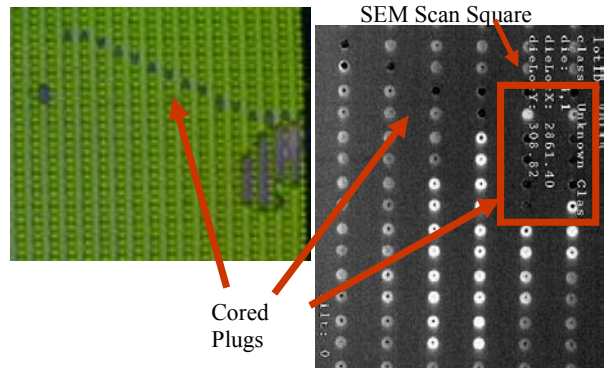
Figure 2: Same Defect as Figure 1, after Post-SEM Clean - The Tungsten Plugs Are Cored Where the SEM Beam Impinged (Optical and SEM Images.)

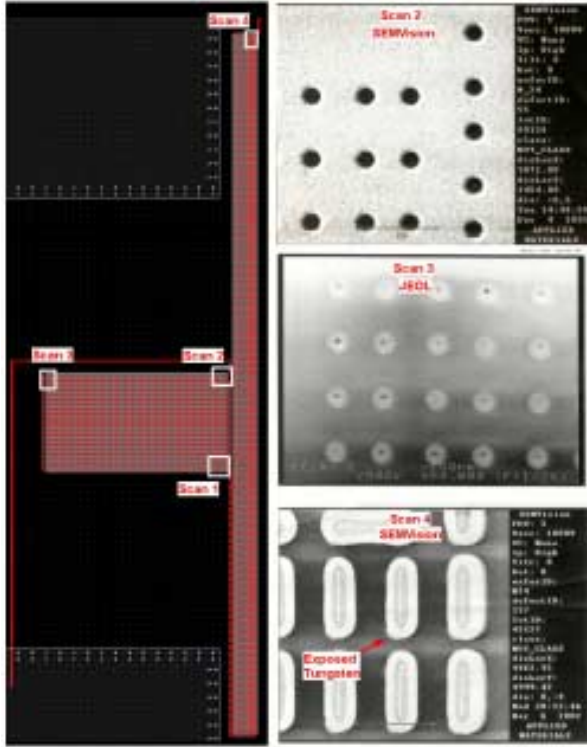
The four areas of the stitches scanned by the SEMs are indicated in Figure 5. It should be noted here that metal-1 was intentionally misaligned in both the X and Y direction by $\sim 80\mu\text{m}$. This amount of misalign is the upper limit of the specification for overlay tolerance and will allow for the underlying plug to be exposed. This can be seen in the final SEM image of Figure 5. To restate, this amount of overlay is within the technology specification. After the two wafers completed the fourth run of SEM inspections, they were split.

Figure 5: SEM Scan Locations after (1) Window Etch, (2) Window Liner Deposition, (3) Tungsten CMP, (4) Metal-1 Etch, With Accompanying SEM Image

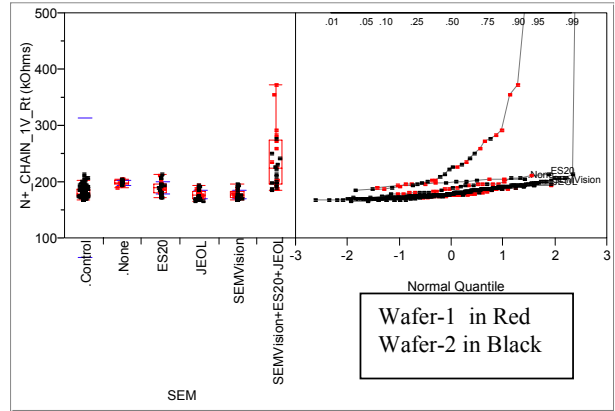
Figure 6: Oneway Analysis of Win-1 to 1.5V NSD Stitch Resistance By SEM Inspection, With Quartile Plot

It is evident from quartile plots for the four thinox stitches, that the sites that received SEM inspection by all three SEMs have considerable disturbances in resistance. The mean, median and standard deviation of the stitch resistance for the combined cell is significantly greater than any of the other cells of the experiment as well as the control cell. While the upper and lower quartiles for all but the combined SEM NSD stitches fall between approximately 170 and 200 k Ω for both the 1.5V and 3.3V, the NSD quartiles for the combined SEM cell fall between ~200 and 325k Ω . While the upper and lower quartiles for all but the combined SEM PSD stitches fall between approximately 475 and 650 k Ω for both the 1.5V and 3.3V, the PSD quartiles for the combined SEM cell fall between ~640 and 3300 k Ω . In addition, for the four source/drain stitches approximately 10% of the combined SEM structures have measured resistances in the megohms up to and including electrical opens. For the other five cells the few opens that occurred were obvious outliers and the distributions were much tighter. Scanning electron microscope imaging has caused the electrical failure of window-1 to source/drain contacts.

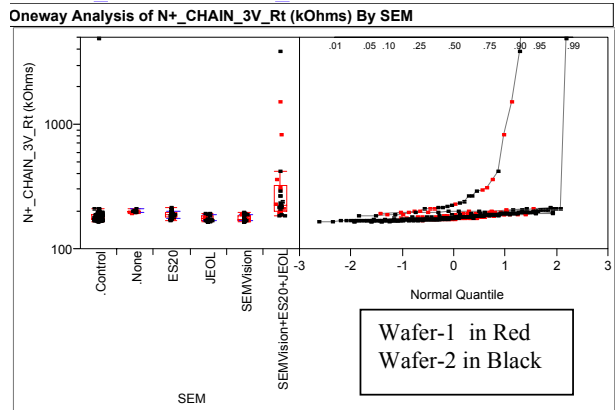
Figure 7: Oneway Analysis of Win-1 to 3.3V NSD Stitch Resistance by SEM Inspection, With Quartile Plot

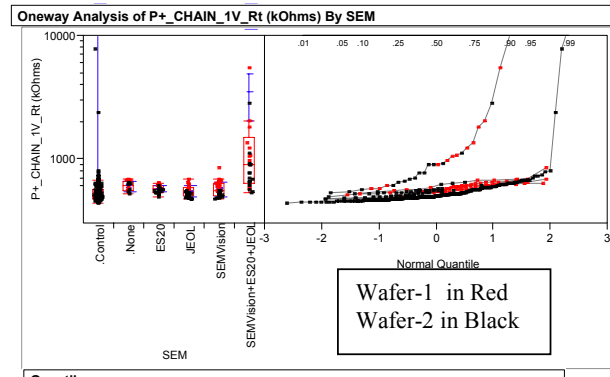
Figure 8: Oneway Analysis of Win-1 to 1.5V PSD Stitch Resistance By SEM Inspection, With Quartile Plot

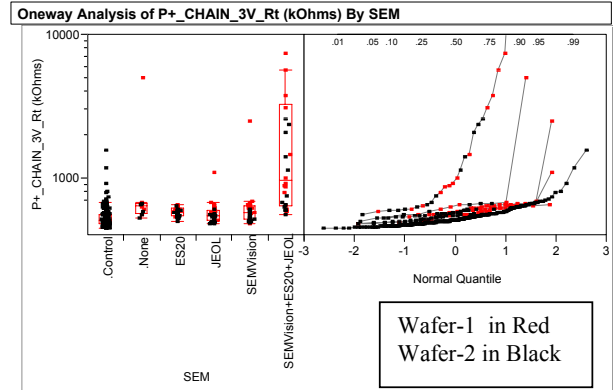
Figure 9: Oneway Analysis of Win-1 to 3.3V PSD Stitch Resistance By SEM Inspection, With Quartile Plot

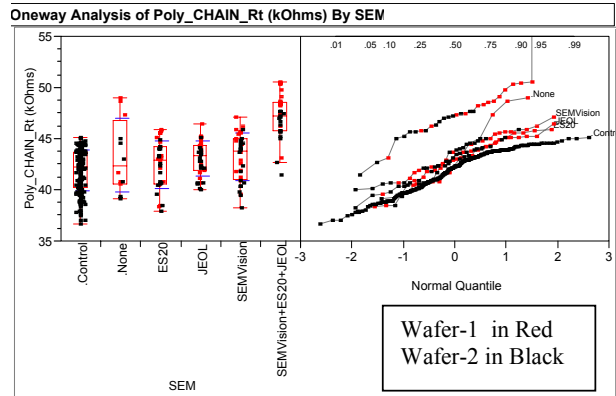
Figure 10: Oneway Analysis of Win-1 to Poly-Silicon Gate Stack Stitch Resistance By SEM Inspection, With Quartile Plot

For the window-1 stitch to gate, there is also a statistically significant increase in measured resistance, however, the gate stitches did not show the high number of catastrophic failures that the source/drain stitches showed. Figure 11 replots the window-1 to poly stitch excluding a single outlier data point from the combined SEM cell.

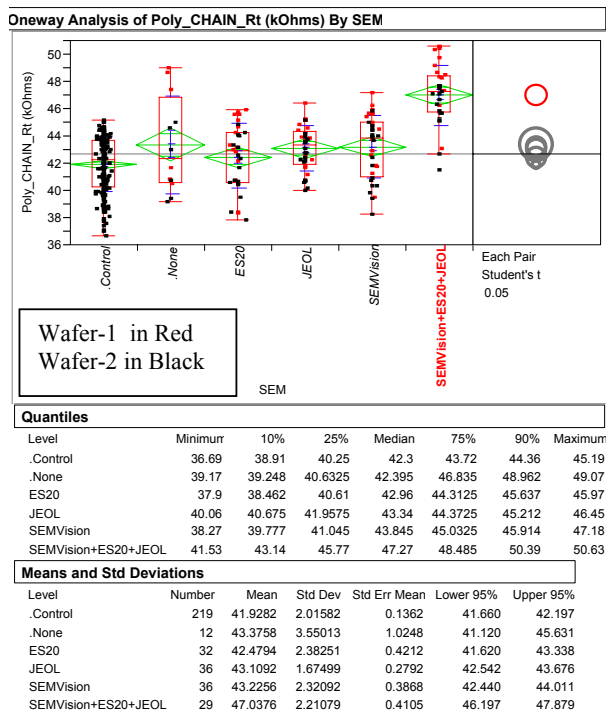
Figure 11: Oneway Analysis of Win-1 to Poly-Silicon Gate Stack Stitch Resistance By SEM Inspection, Excluding a Single Outlier Point From Combined SEM Cell

In this case, the mean of the combined SEM cell increased from ~43k Ω to ~47k Ω as compared to the other experimental cells, which is an increase of only ~9%. In addition, the standard deviation remained similar between the cells with no increased spread in the distribution of the resistances for the combined SEM cell. This percentage increase may seem inconsequential, but if it can be assumed that only one of the four scan points was responsible for the increase (not necessarily a safe assumption) then that 4k Ω resistance was caused by a scan area of only a few square microns, encompassing twenty windows or less. This is, potentially, an average increase of 200 Ω per contact, for a gate contact resistance that normally measures ~10 Ω per contact.

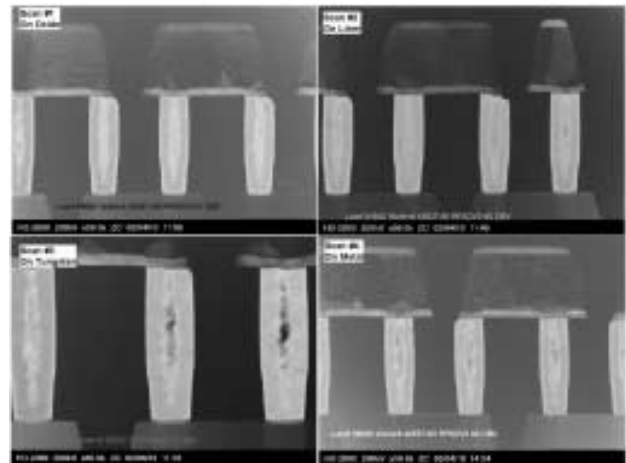
Figure 12: Scanning TEM Cross-Sectional Micrographs of the Four SEM Scan Areas From Electrically Open Failing Stitches

The random cross-sections did not identify either the failure locations or the failure mechanism. In fact, cross-sections indicate well formed and filled windows, with no apparent foreign interfaces, between silicon and liner, between liner and tungsten, or between tungsten and Ti/TiN barrier.

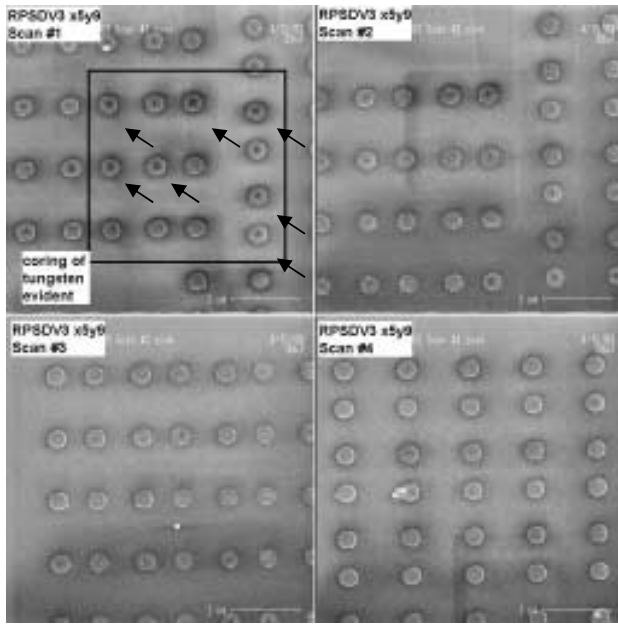
Figure 13: Top-Down SEM of the Four Scanned Areas on a Failing 3.3V PSD Stitch After the Removal of Metal-1 – Tungsten Coring Evident In Scan Area #1

Top-down SEM imaging of the failing source/drain stitches gives an indication that the source of the electrical variation may be in SEM scanning of the oxide surface (scan #1) prior to the window Ti/TiN liner. High magnification images of these windows clearly indicate incomplete tungsten fill.

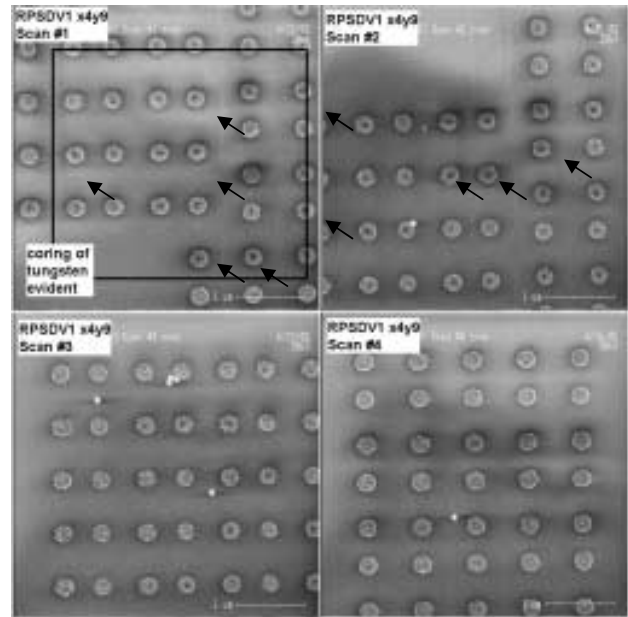
Figure 14: Top-Down SEM of the Four Scanned Areas On a Failing 1.5V PSD Stitch After the Removal of Metal-1 – Tungsten Coring Evident In Scan Area #1

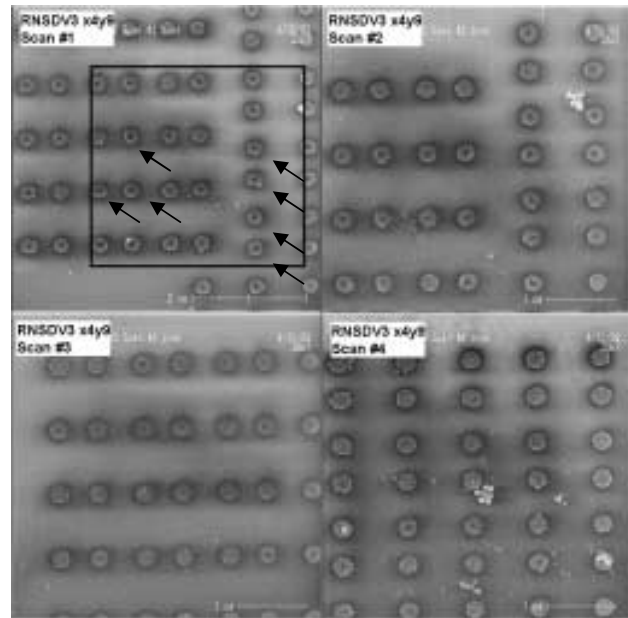
Figure 15: Top-Down SEM of the Four Scanned Areas On a Failing 3.3V NSD Stitch After the Removal of Metal-1 – Tungsten Coring Evident In Scan Area #1

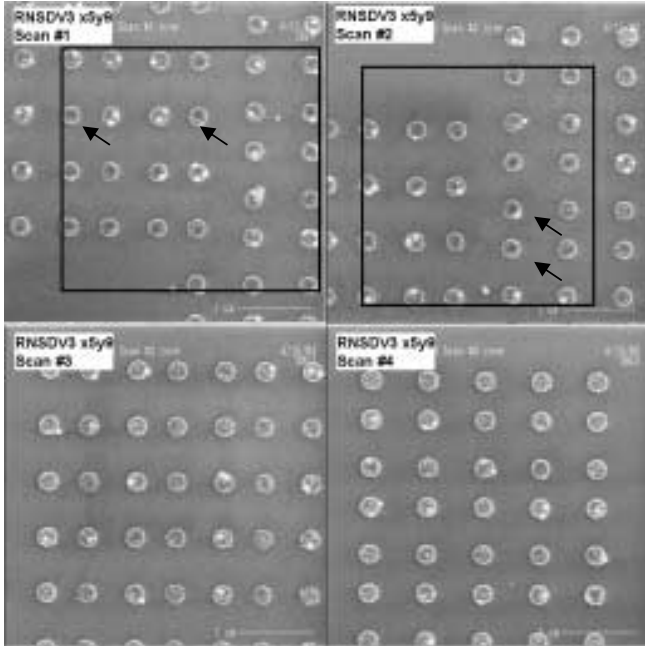
Figure 16: Top-Down SEM of the Four Scanned Areas On a Failing 3.3V NSD Stitch After the Removal of Metal-1 – Tungsten Coring Evident In Scan Area #1

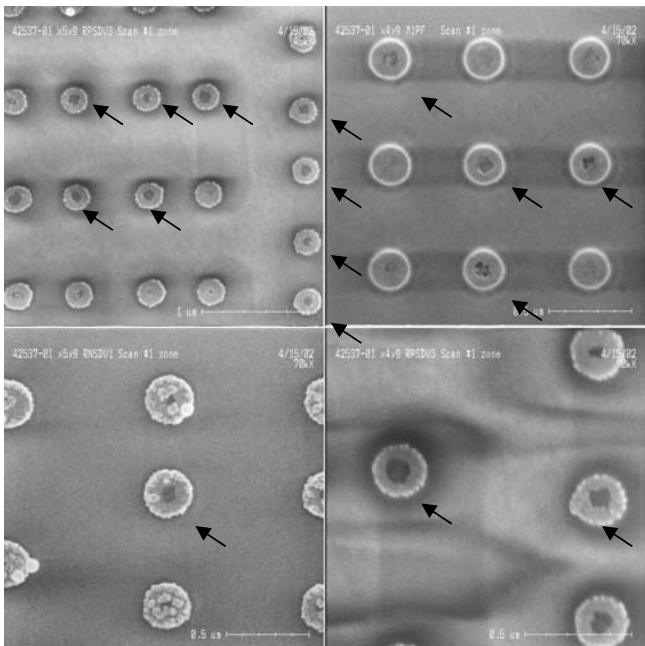
Figure 17: High Magnification SEM Images of Incompletely Filled Window-1 in Scan Area #1.

In some instances, the area that received SEM scans after liner deposition (scan #2) also showed some degree of incomplete fill. Scan areas #3 and #4 did not show any coring; rather the windows appeared to be correctly filled. Because the precise location of the failing window was not pinpointed, the incompletely filled windows must be considered circumstantial, but they are at the very least an indication of the process step which is most detrimental to submit to inline SEM inspection
