SCANNING ELECTRON MICROSCOPE INDUCED ELECTRICAL BREAKDOWN OF TUNGSTEN WINDOWS IN INTEGRATED CIRCUIT PROCESSING

David M. Shuttleworth*
Agere Systems, Orlando, Florida

Abstract

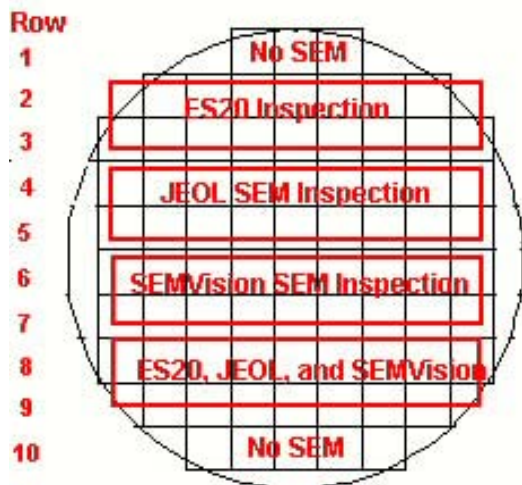
Figure 3: Wafer Layout Identifying SEM Inspection Row

Two wafers (wafers 01 and 02) were processed through metal-1, capped and pulled from the line for electrical testing and analysis. The wafer layout consists of a total of 76 flash fields laid out in 10 rows by 11 columns. Figure 33 depicts the wafer with row labels. Row 1 and 10 did not undergo SEM inspection at any time. Rows 2 and 3 underwent ES20 inspection. Rows 4 and 5 underwent JEOL inspection. Rows 6 and 7 underwent SEMVISION inspection. Rows 8 and 9 underwent inspection by all three SEMs at precisely the same spots on the stitches so that the inspections overlapped.

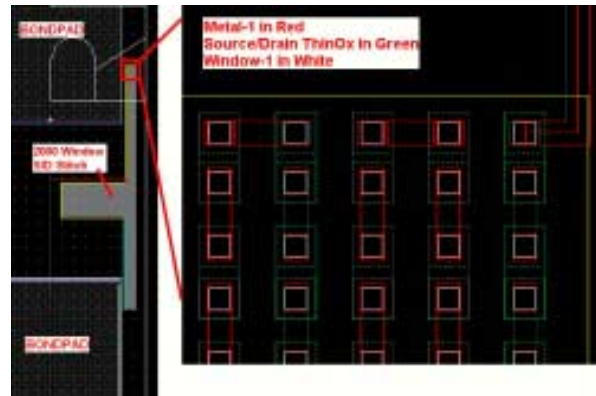
Figure 4: Schematic of 2000-Window Source/Drain Stitch

The layout of the source/drain stitch is seen in Figure 4. There are 2000 windows laid out at $0.20\mu\text{m}$ X $0.20\mu\text{m}$. The metal pads are $0.24\mu\text{m}$ in width with a $0.02\mu\text{m}$ extension on either side of the window and an extension beyond window of $0.06\mu\text{m}$.
